NASA Unmanned Flight Anomaly Report:

INVESTIGATION OF ENVIRONMENTALLY-INDUCED ANOMALIES ABOARD JPL SPACECRAFT

June 1995

Jet Propulsion Laboratory
California Institute of Technology
Pasadena, California

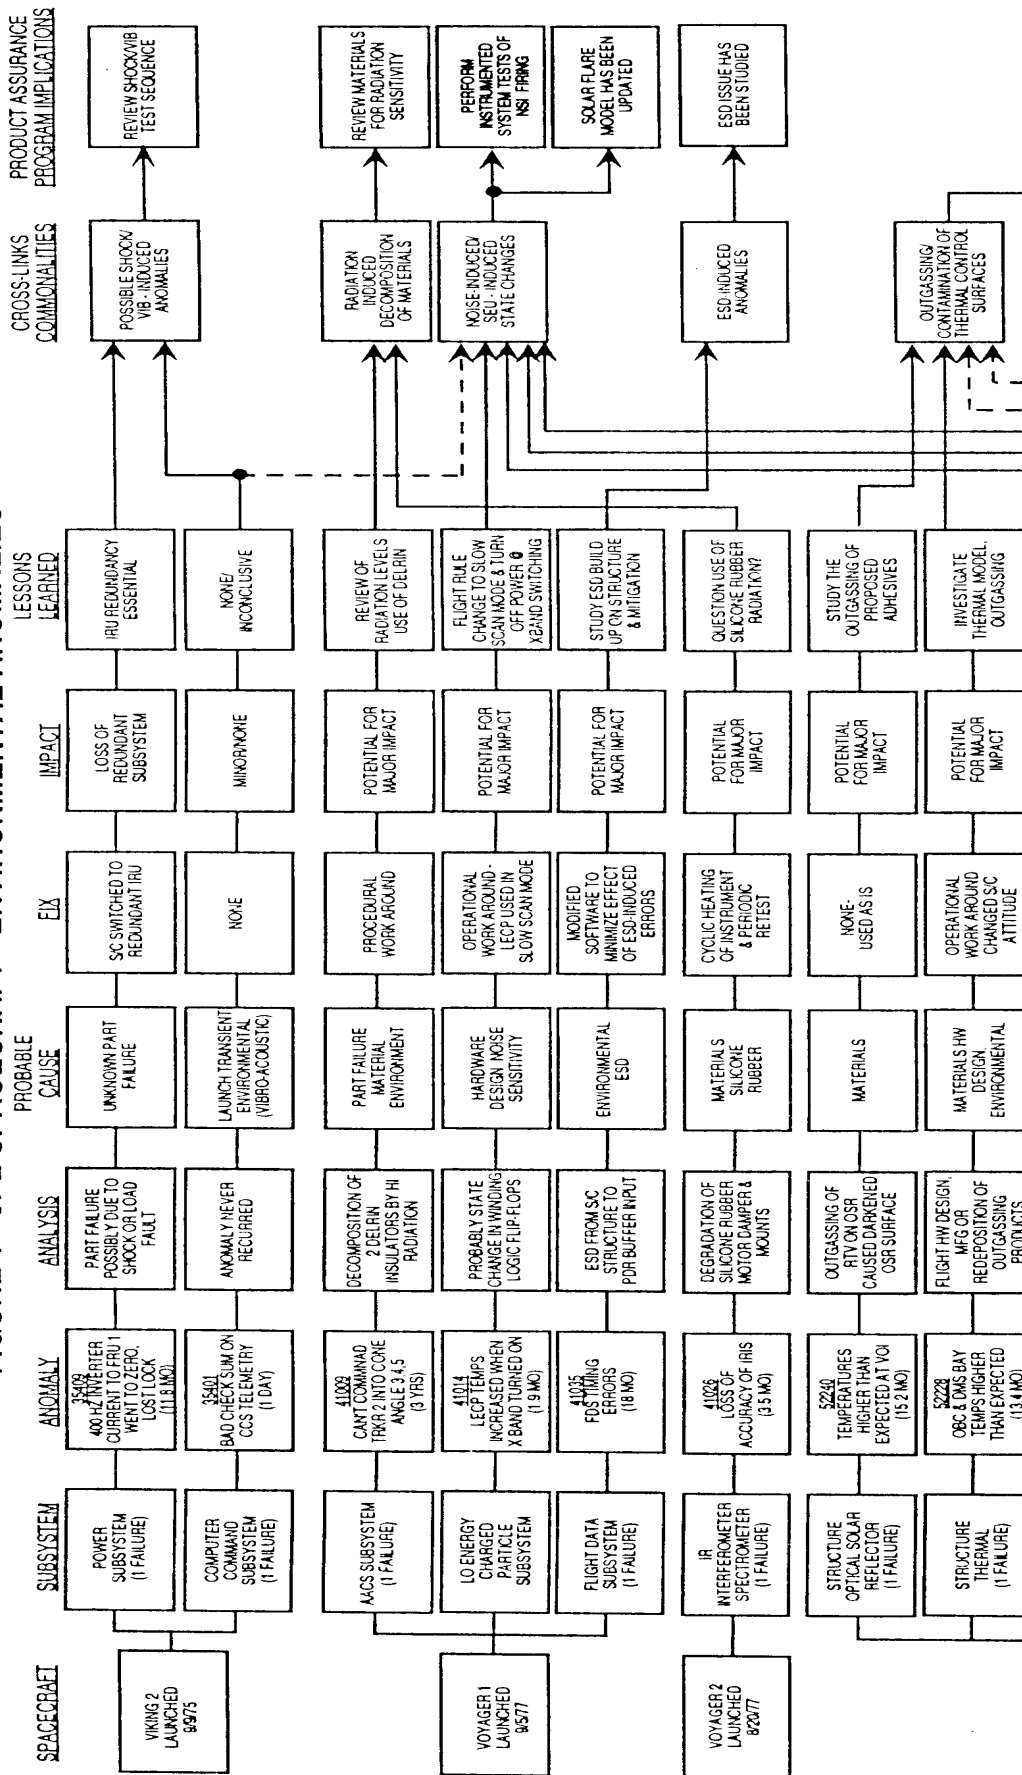
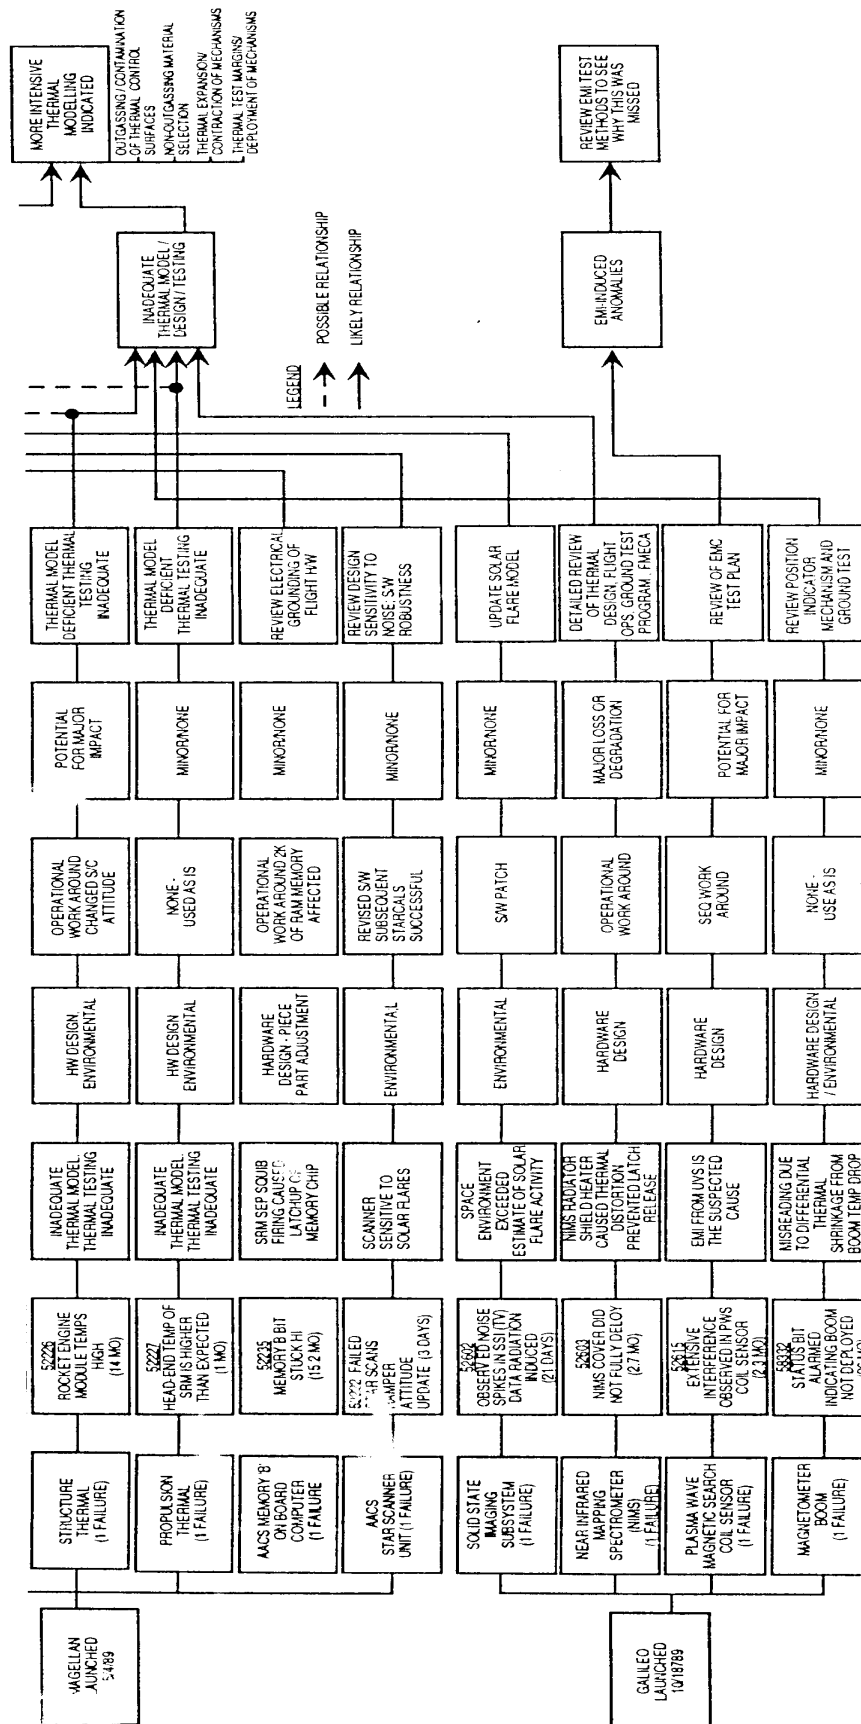
FIGURE 1 - JPL SPACECRAFT - ENVIRONMENTAL ANOMALIES

The anomaly characterizations in Figure 1 include the following incidents documented by JPL Problem/Failure Reports (PFRs) where in-flight anomalies were attributed to environmental exposure:

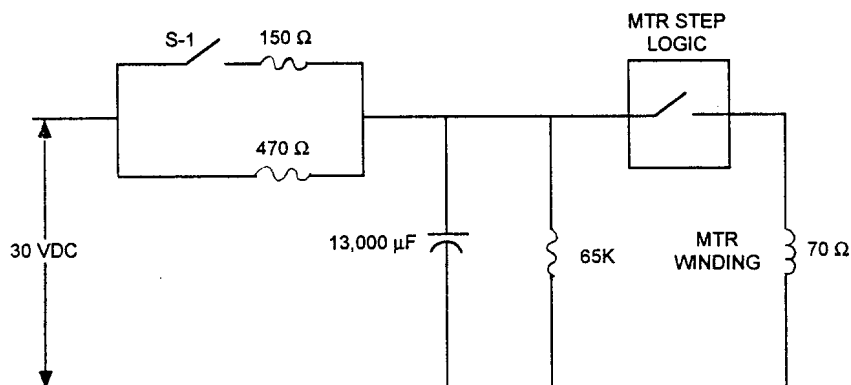
Figure 2
Simplified LECP Motor Stepping Circuit

Analysis of anomaly data traced the problem to the switch in the motor step logic circuit (Figure 2). Pulsed open and closed in normal motor stepping operation, the switch stuck in the closed position for the duration of the high temperature anomaly. This allowed the motor winding in series with the logic circuit to draw about 7 watts continuously for 18 hours. Since switch S-1 is closed in the "accelerated motor step rate" mode of operation, the excess power would have overloaded and damaged the 150 ohm, ½ watt resistor in series with S-1. Dissipation of the excess power by the circuit was viewed as a likely cause of the observed temperature rise in the instrument. Since the anomaly was coincident with X-band transmitter powering, it is likely that a power transient associated with that event effected a state change in the logic. Tests conducted to simulate power dissipation through the ½ watt carbon composition resistor resulted in a significant reduction in the resistance value of the part.

The prospect of lowered resistance in the motor stepping circuit raised concern about excessive current flow in the accelerated stepping mode. The anomaly is rated as "Potential for Major Impact." Circuit analysis shows that the resistance change would not affect LECP operation in the slow scanning mode, which restricts step pulsing to once every 48 seconds. To prevent damage to the instrument, JPL provided a software patch which keeps switch S-1 in the open position, proscribing future use of the accelerated mode. Corrective action also included generation of a safing sequence to turn LECP motor power off during all X-band power changes. With these remedies in place, the instrument completed its mission successfully.
